WELCH LAKE DAM

BOONE COUNTY, MISSOURI

MO 10733

**PHASE 1 INSPECTION REPORT
NATIONAL DAM SAFETY PROGRAM**

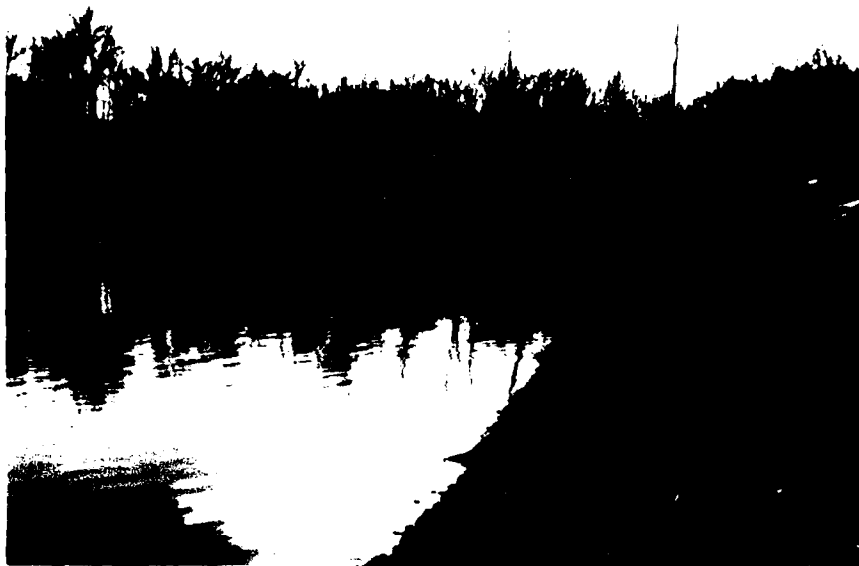
PHOTO 1. UPSTREAM FACE OF DAM
